**Preassessment Screen and
Determination: Rio Algom Mines
and Quivira Mill Site,
McKinley County, New Mexico**

New Mexico Office of Natural Resources Trustee
Albuquerque, New Mexico

September 2010

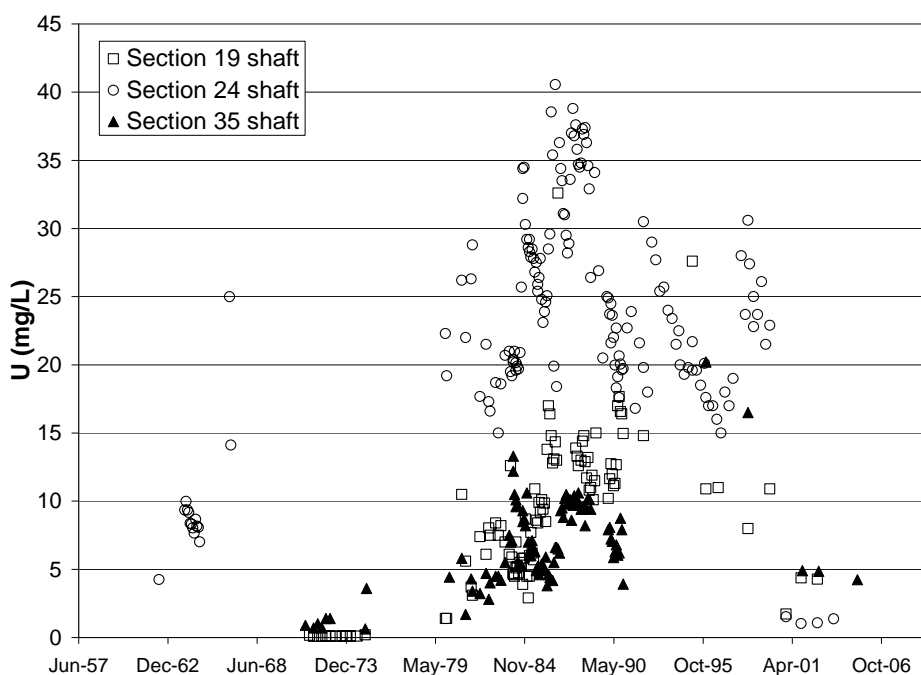
The results in Table 3.2 show the presence of hazardous substances¹ in deep groundwater at the Site. Figure 3.4 shows concentrations of uranium in groundwater increasing over the course of mining. Concentrations generally peaked in the mid-1980s, possibly associated with the use of old stope mining methods. Concentrations of sulfate, radium, and selenium in deep groundwater also increased after mining began (NMED, 2007b).

Figure 3.4. Uranium concentrations in Sections 19, 24, and 35 mine shafts from the early 1960s to 2005. The federal and State drinking water standard for uranium is 0.03 mg/L; the State standard was 5 mg/L prior to June 1, 2007 (NMED, 2007a).

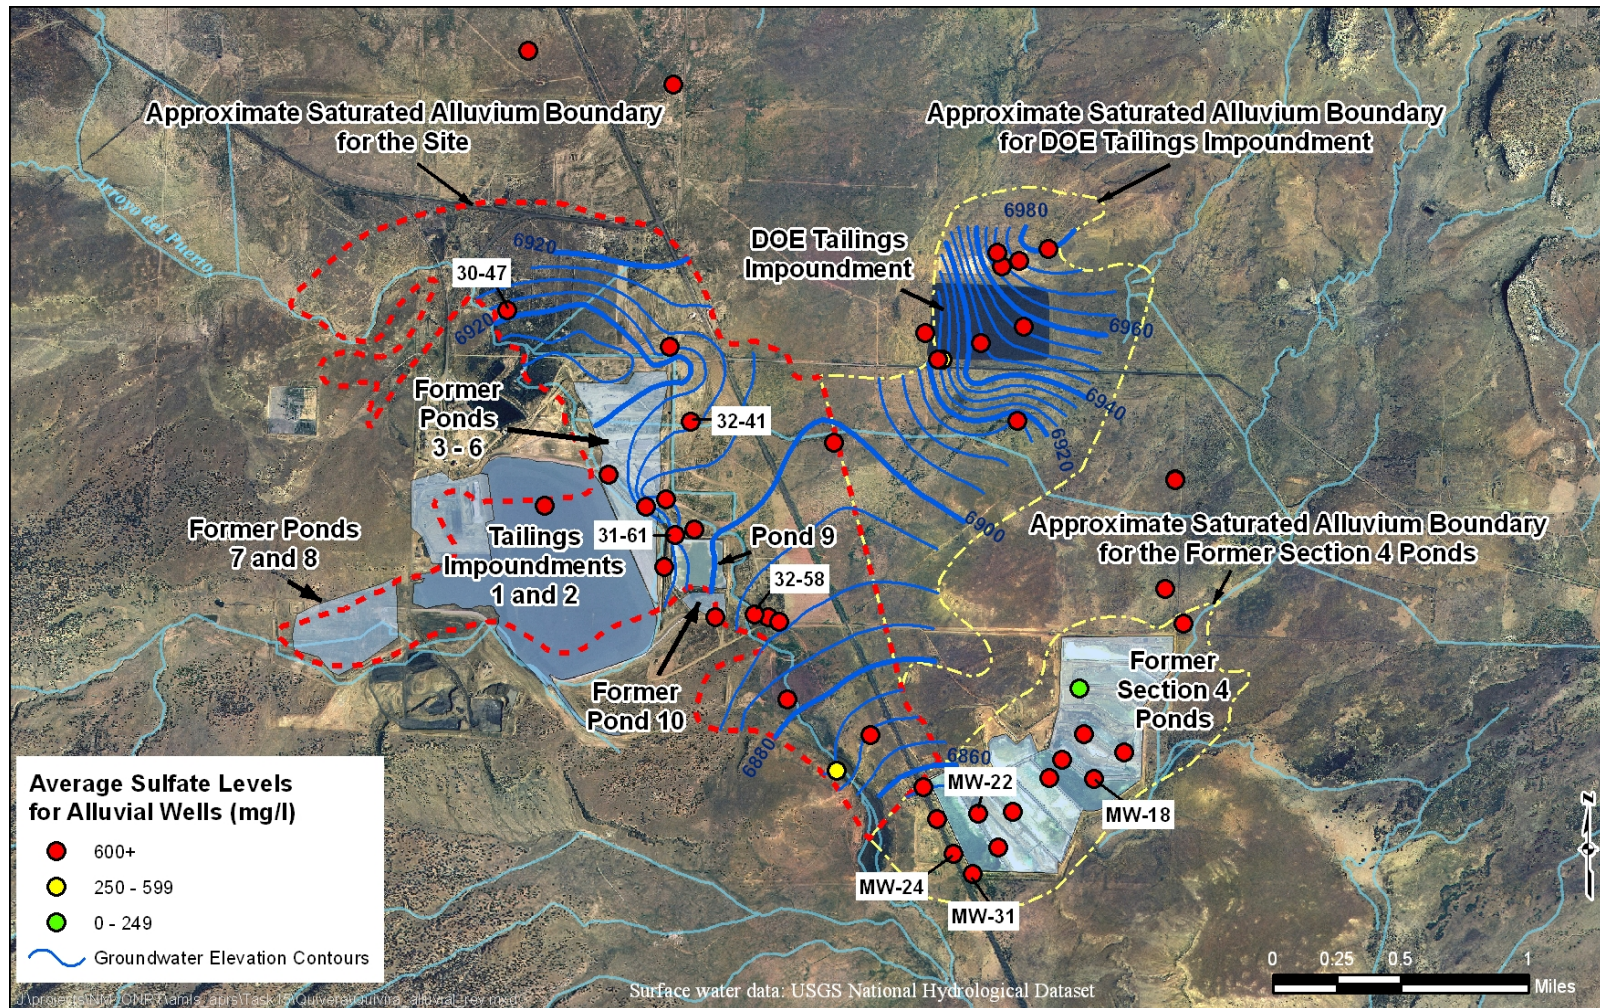
Elevated concentrations of mining-derived hazardous substances are also present in alluvial groundwater, including elevated concentrations of SO₄, lead-210, uranium, radium, selenium, thorium, and gross alpha emissions (data received from NMED, 2007b). Table 3.3 contains mean, minimum, and maximum values for SO₄, pH, and radionuclides in alluvial groundwater. Figure 3.5 shows widespread elevated SO₄ concentrations in alluvial wells throughout the Site.

Figure 3.5. Sulfate concentrations in alluvial wells at the Site and estimated areal extent of saturated alluvium for different parts of the Site.

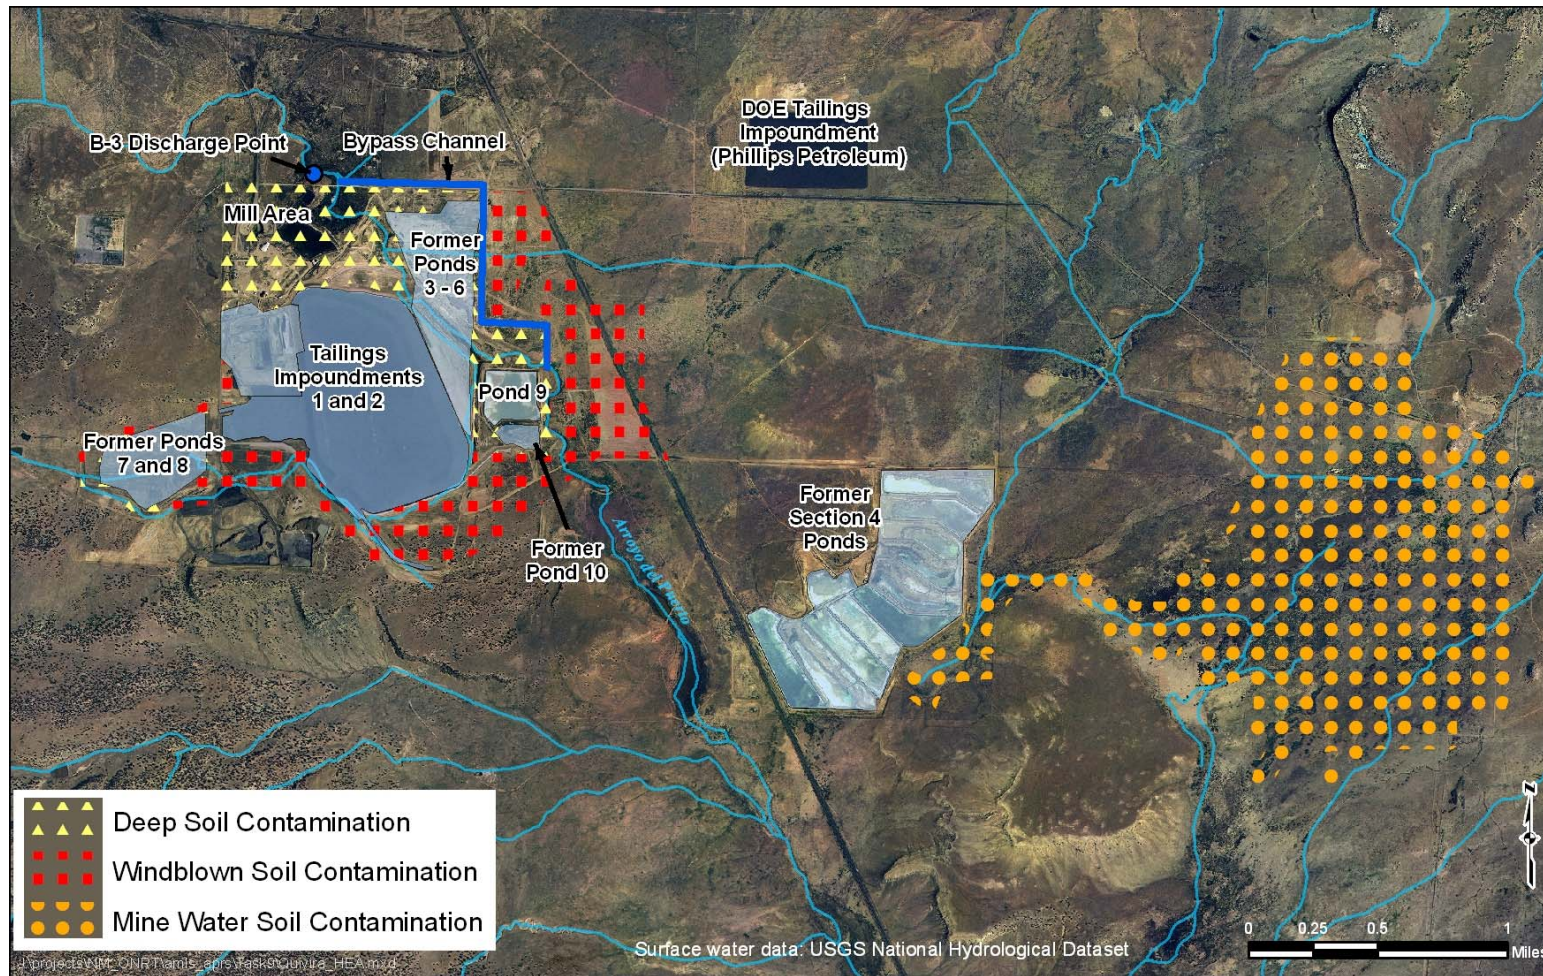
Figure 3.6 shows areas of the Site with soils that may have been exposed to hazardous substance releases. A brief review of contaminant concentrations in specific areas follows.

Figure 3.6. Areas where mining activities have potentially impacted soils at the Site.

Soils at the Site have also been exposed to hazardous substances as a result of discharges of mine waters from Section 35/36 mines to an area east of the former Section 4 Ponds (Figure 3.6; INTERA, 2007). Contaminant concentrations in soil leachate (Tables 3.6 and 3.7) and in soils (Tables 3.8 and 3.9) collected east of the former Section 4 Ponds indicate that geologic resources have been exposed to and potentially injured by releases of radionuclides, metals, and metalloids from the Site. The high concentrations of hazardous substances in leachate samples suggest that soil could also serve as a pathway for contamination of underlying groundwater.

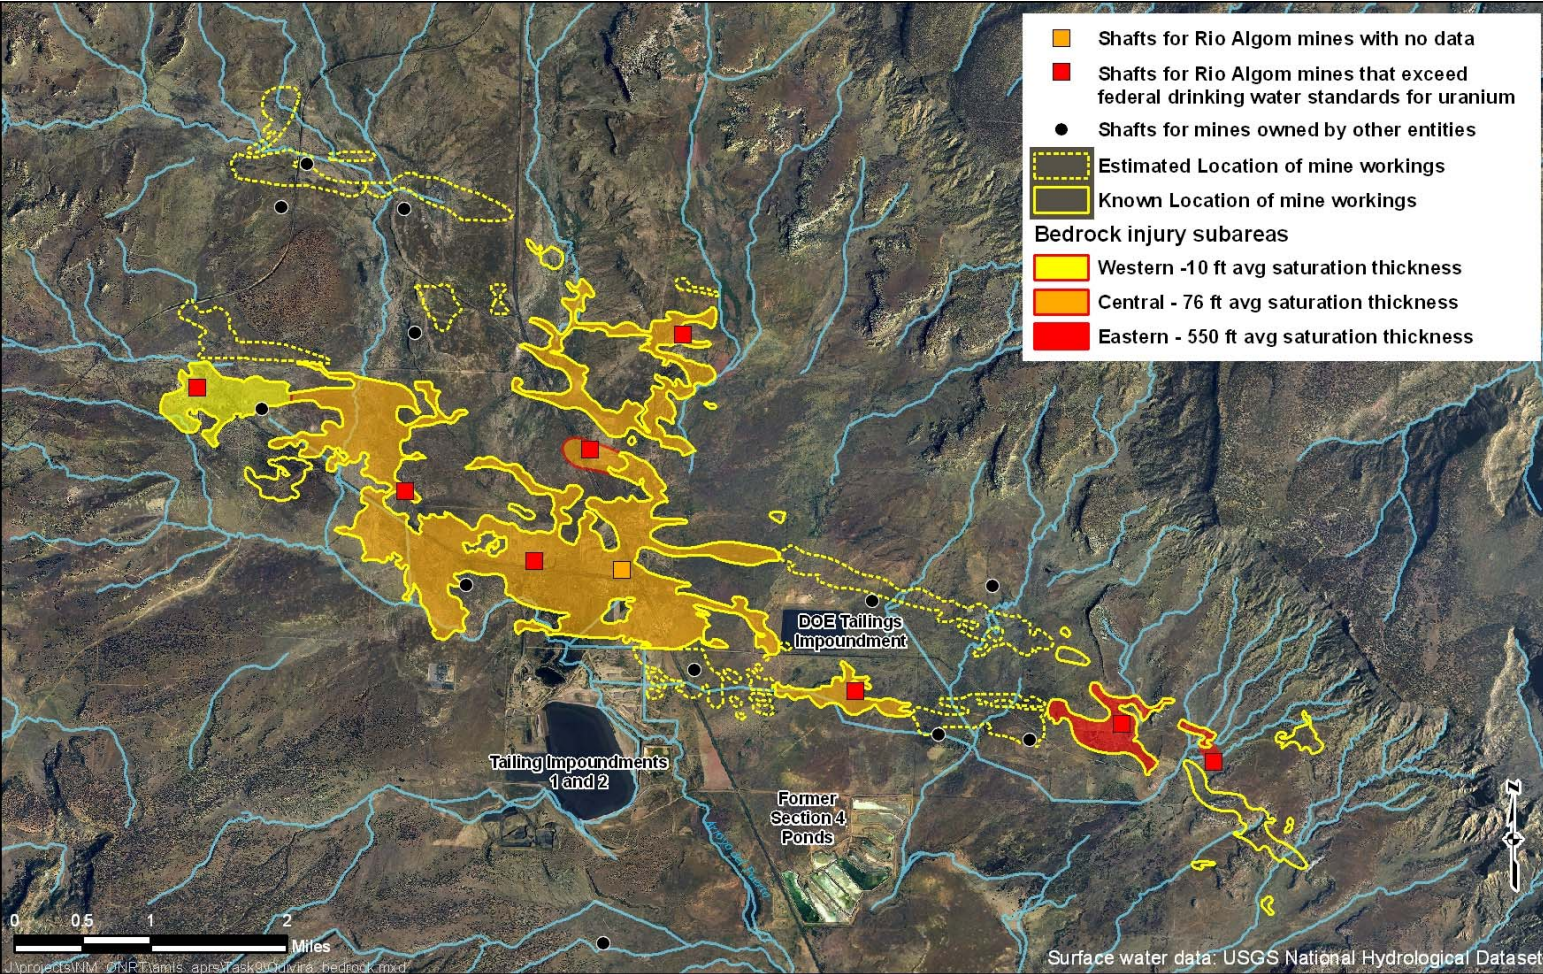
Figure 4.1. Uranium exceedences in bedrock groundwater near the Site in western, central, and eastern portions of the bedrock groundwater.

exceeds the water quality standard by over one order of magnitude (Table 4.2). These data suggest that releases at the Site have been sufficient to potentially cause injury to groundwater resources over a widespread area (Figure 4.1).
