Cimarron Canyon Natural Resources Restoration Plan for the Fronk Oil Spill Public Review Draft

New Mexico Office of Natural Resources Trustee

February 17, 2021

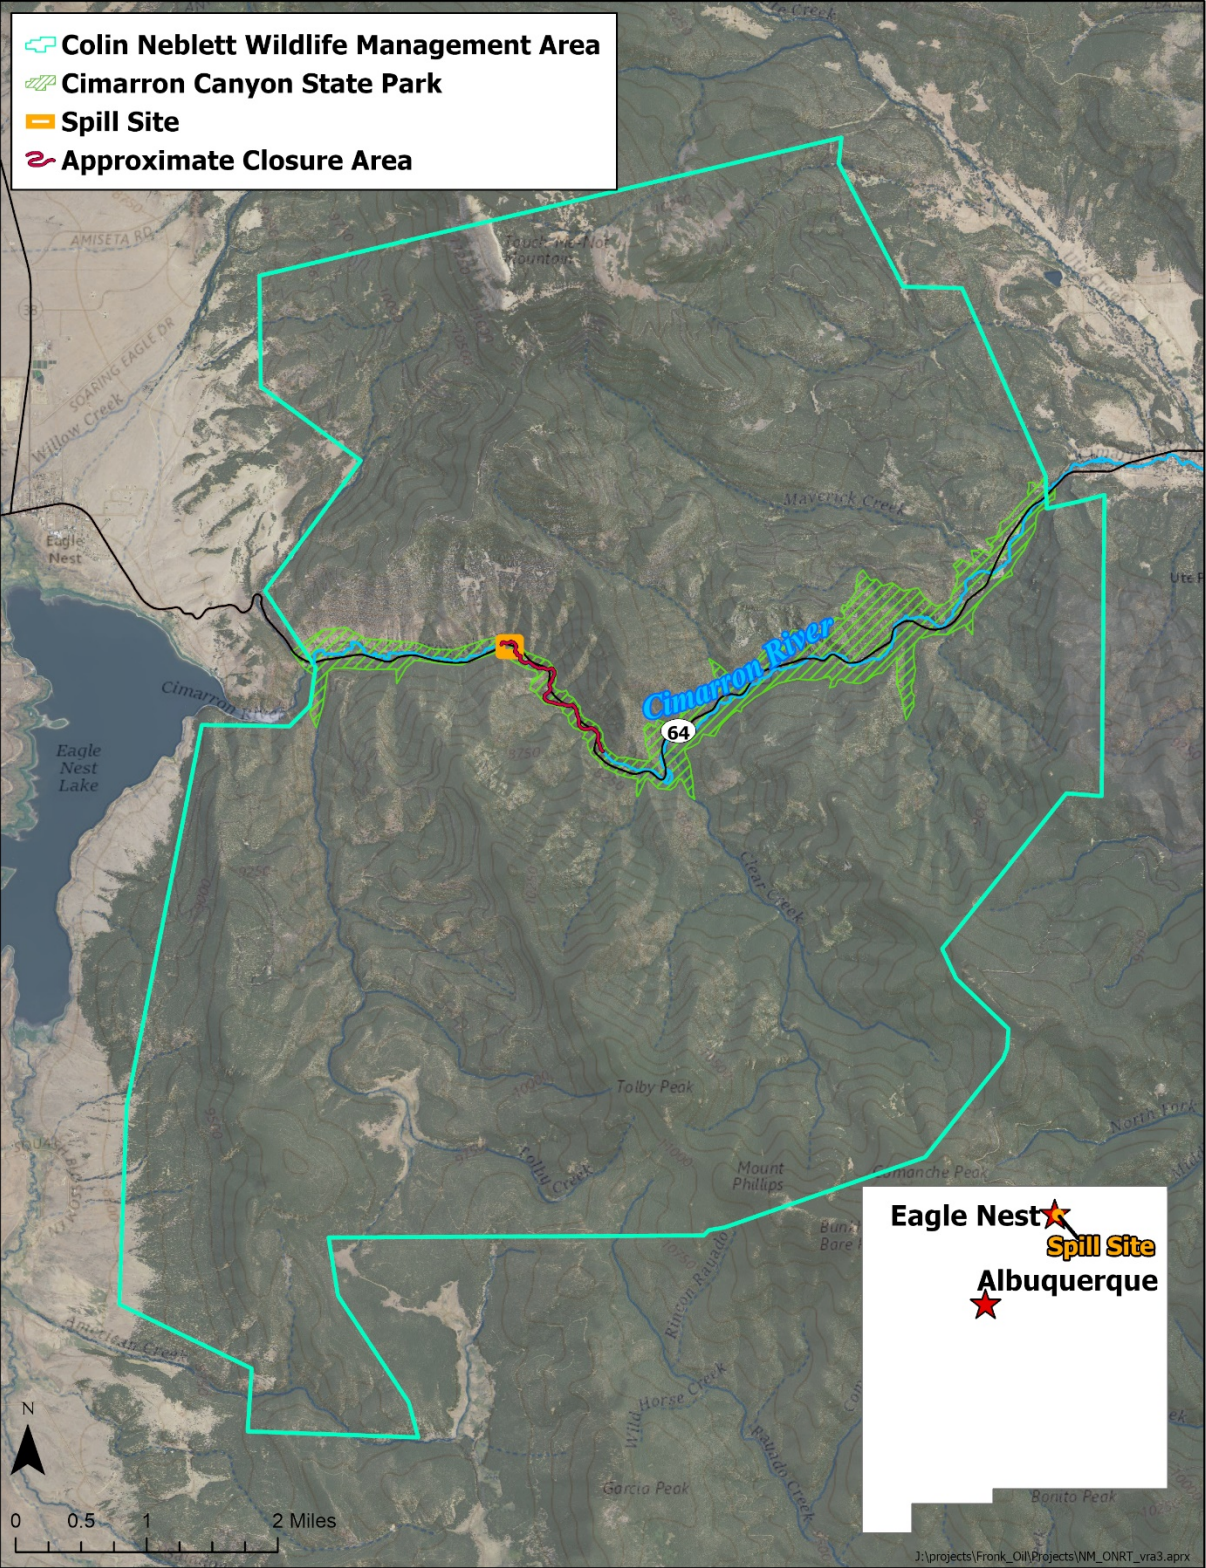
Figure 1. Location of the Fronk Oil tanker spill.

On December 27, 2016, a Fronk Oil tanker truck carrying unleaded gasoline was involved in an accident approximately 5 miles east of Eagle Nest, New Mexico (Figure 1; NMED, 2017a). The accident caused the release of approximately 1,100 gallons of unleaded gasoline that the truck was carrying, as well as the release of diesel fuel from the saddle tanks of the truck, into the Cimarron River located in the CNWMA (Figure 1; NMED, 2017a). The spill killed fish and macroinvertebrates in the river; contaminated water, soils, and sediments; and resulted in an advisory to limit the consumption of fish caught in the spill area (NMDGF, 2017a).

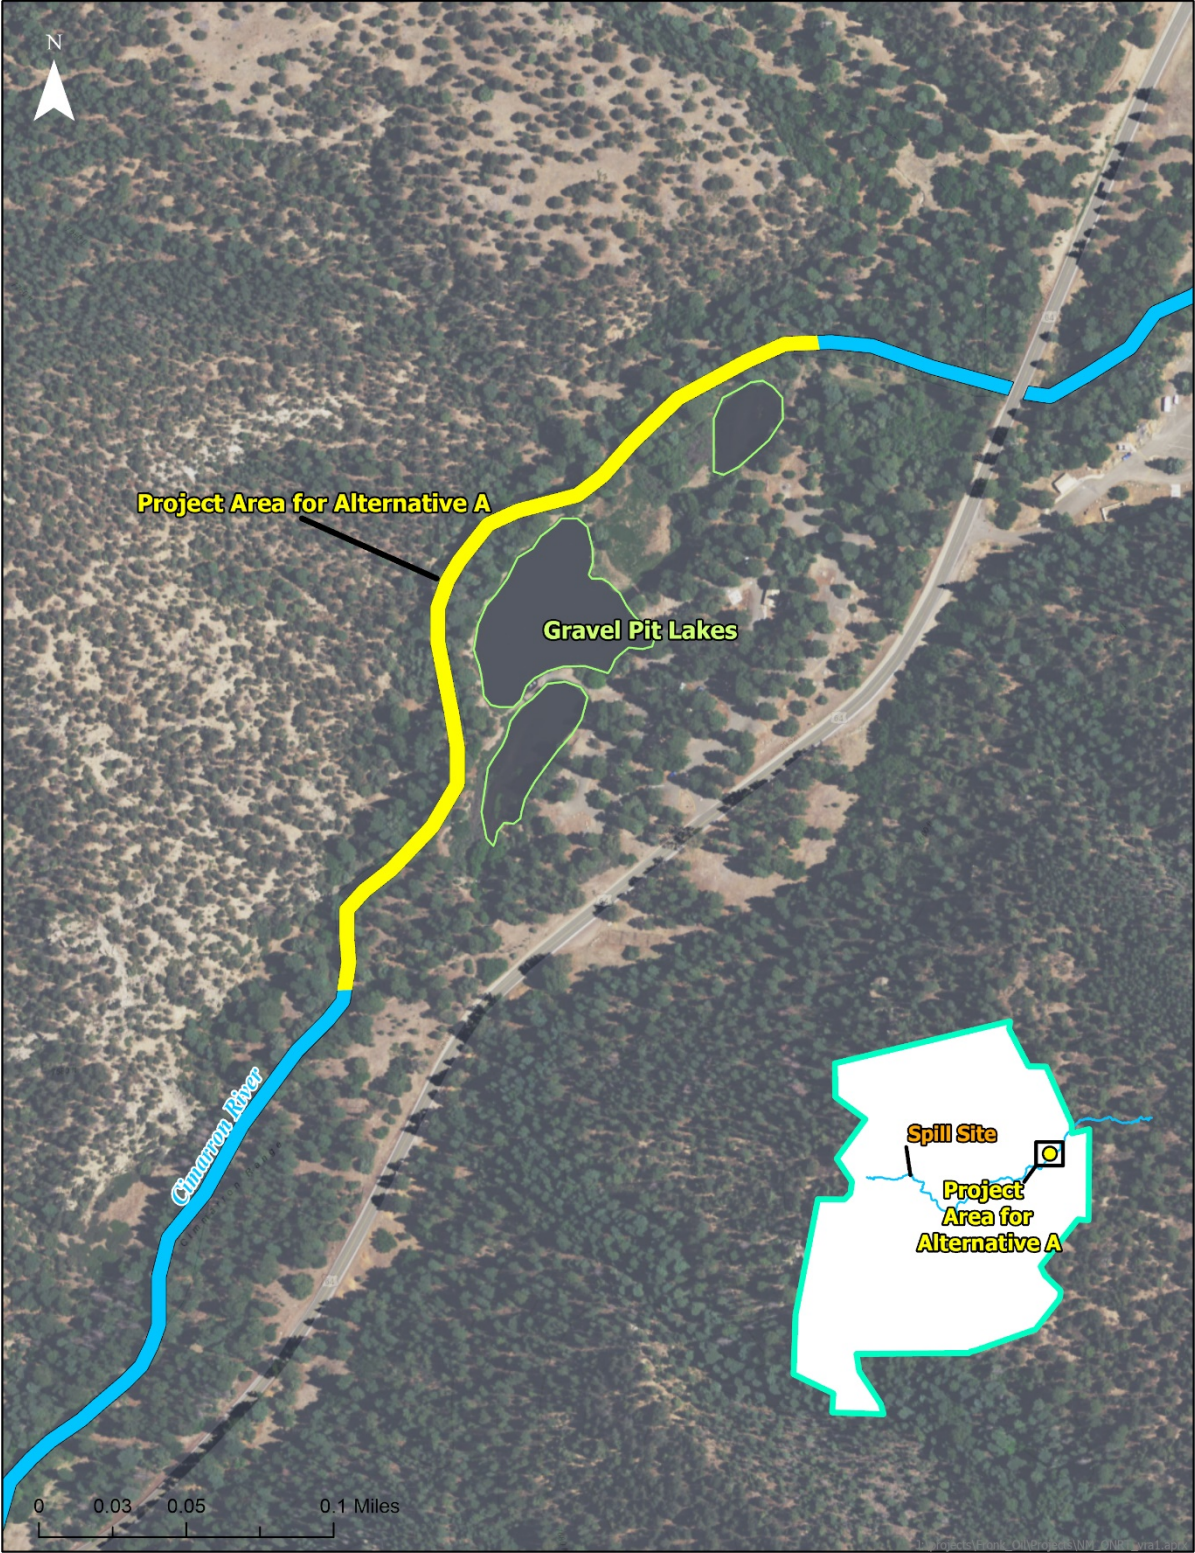
Figure 5. Location of Alternative A and the Gravel Pit Lakes.

The restoration would occur in the Cimarron River, approximately 5 river miles downstream from the location of the spill, where the river travels through the CCSP in the CNWMA (Figure 4). Habitat quality for overwintering trout is poor in this reach of the river, due to low flows combined with a lack of stream complexity and the absence of pools. Flows in this area are lowest in the winter due to Eagle Nest Dam operations (SWQB, 2010). Streamflow in this reach is dependent on releases from the Eagle Nest Dam, which is located approximately 2.3 river miles upstream of the spill site. Water is released to meet irrigation demands downstream during the growing season (June 15–October 31; SWQB, 2010). In the winter months when water is stored in the Eagle Nest Lake, flows in the Cimarron River can be very low.

Further, up to half of the flow in the main channel along this stretch is currently diverted to the Gravel Pit Lakes, located adjacent to the river (Figure 5). Though the lakes were anthropogenically created as a result of historical gravel mining, they currently provide habitat benefits including calm water refugia and wetland habitat, and are a popular fishing destination. However, the current volume of flow diverted to them is deleterious to the main channel of the river (particularly in the winter, when flows are already low), and the sedimentation rate associated with the diverted river flow is undesirable for the lakes. If no action is taken along this water-impooverished stretch of the Cimarron River, the connectivity between the Cimarron River above and below the Gravel Pit Lakes could be lost altogether, and sedimentation will eventually fill up the Gravel Pit Lakes, resulting in the loss of this calm water and wetland habitat.

Accordingly, this alternative would involve two distinct components to improve habitat within the stream channel and within the lakes, including (1) the installation of instream habitat features that would create habitat complexity and pools of greater depth, and (2) the construction of a headgate and sediment trap for the Gravel Pit Lakes.
